THE EFFECT OF LEAD ON MICRO-CRACK  
INITIATION AND PROPAGATION IN ALLOY STEELS

PART B: A FRACTOGRAPHIC STUDY OF LEADED 4145 STEEL TESTED  
AT ELEVATED TEMPERATURES

by R. Zipp, Wm. R. Warke, and N. N. Brever  
ILLINOIS INSTITUTE OF TECHNOLOGY

**U.S. ARMY TANK AUTOMOTIVE COMMAND Warren, Michigan**

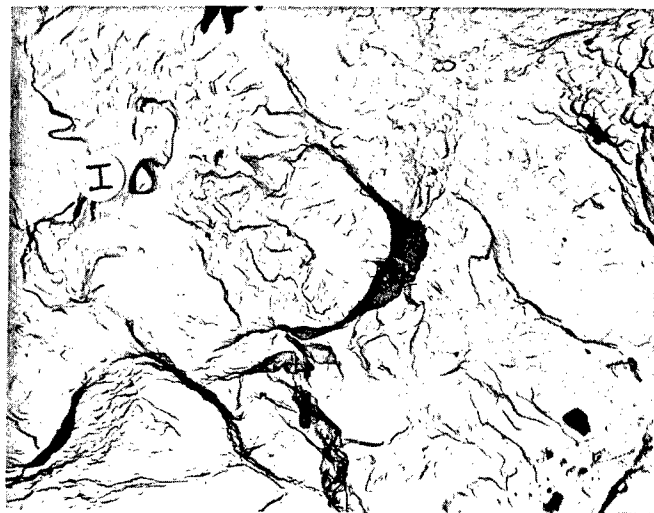
Figure 19b. Primarily Intergranular Fracture for a Type B Fracture. 3,000X

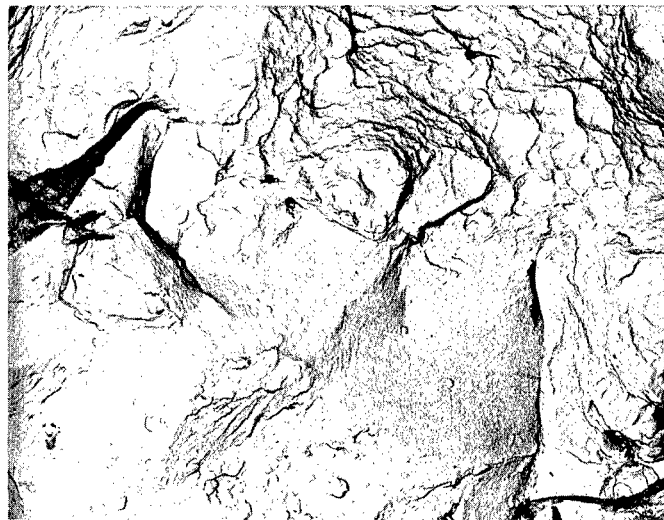
Figure 24. Intergranular and Transgranular Fracture  
Located in the Intermediate Region. 3,000X

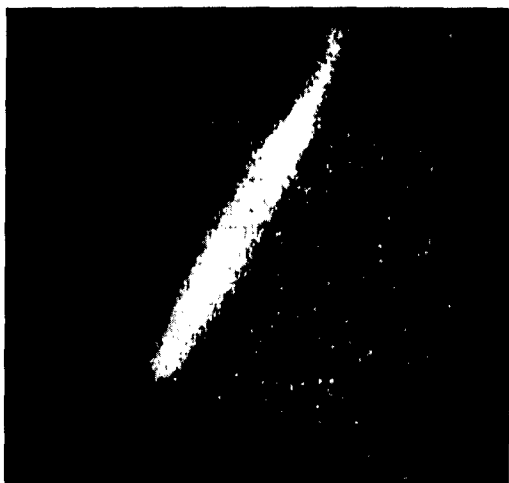
Figure 3B.  $K\alpha$  Radiation Revealing the Presence of Sulfur in the Inclusion.
